# The First Annual Navy Corrosion Control Workshop

# Microbiologically Influenced Corrosion in Copper and Nickel Seawater Piping Systems

## Executive Summary

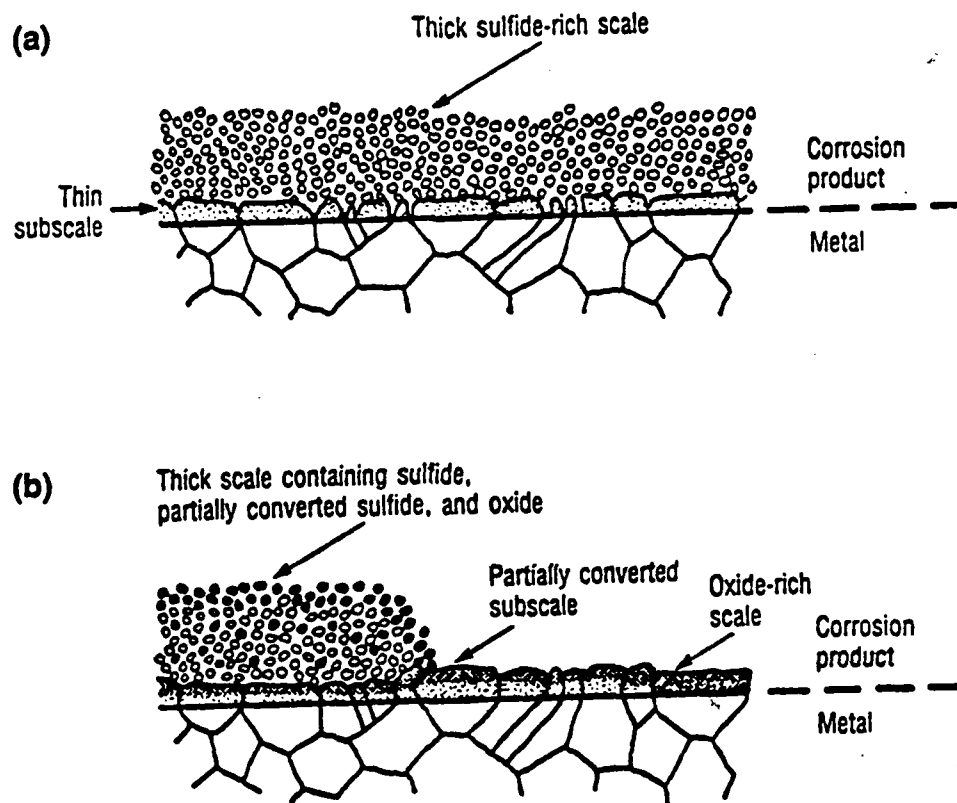
**A. SCHEMATIC OF THICK SULFIDE-RICH SCALE FORMING ON COPPER ALLOY (TAKEN FROM SYRETT, 1980).**

**B. SCHEMATIC SHOWING DISRUPTION OF SULFIDE-RICH FILM ON COPPER ALLOY BY THE INTRODUCTION OF AERATED SEAWATER (TAKEN FROM SYRETT, 1980).**
